# **BCIS-21 Vibration Test**

## ***TEST REPORT***

**Terra Supreme Battery**  
1563 E State Road 8  
Albion, Indiana 46701  
[benny.jay@terrasupremebattery.com](mailto:benny.jay@terrasupremebattery.com)

August 6, 2026  
TÜV Job Number: 721023372  
PO Number: 004338-00

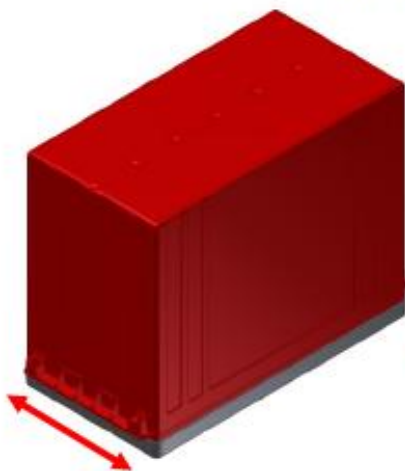
Figure 2A

11.1.1 Vibration Test Orientation.

Inverted

- 7.4 The first test run will be in the inverted position, the second run will be on the battery's side, and for the final cycle the battery will be clamped in the up on end position. The vibrations will be in the directions of the arrow indicated in the drawings. Vibration Test Orientation drawings 11.1.1, 11.2.1, 11.3.1
- 7.5 During the course of, and following, each Vibration Test Orientation, inspect the battery for fluid leakage. (See 5.3)

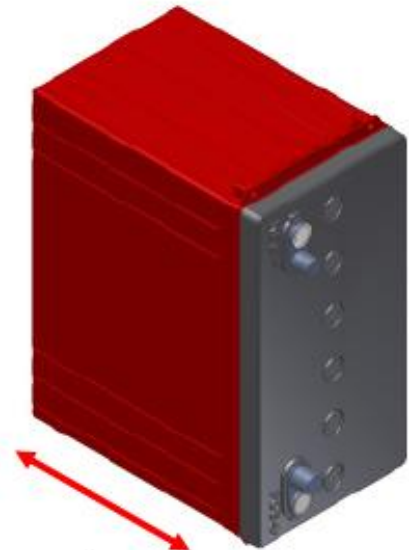
Figure 2C

End
